**FATIGUE BEHAVIOR OF A FUNCTIONALLY-GRADED TITANIUM MATRIX
COMPOSITE**

THESIS

Scott R. Cunningham, Captain, USAF

AFIT/GAE/ENY/05-M06

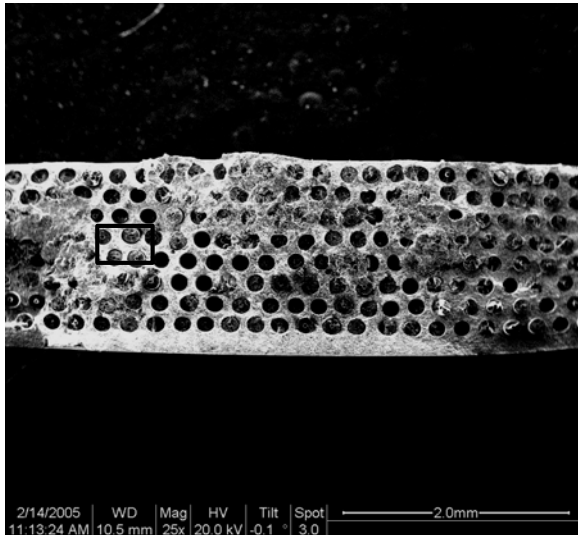
Figure 77: Specimen TMC-06, overall view of fracture surface

At this highest stress level, it is no surprise that fiber failure was the dominating mechanism (see Figure 77). Upon closer investigation of the fracture surface, evidence of ductile void coalescence and necking were observed (see Figure 77).

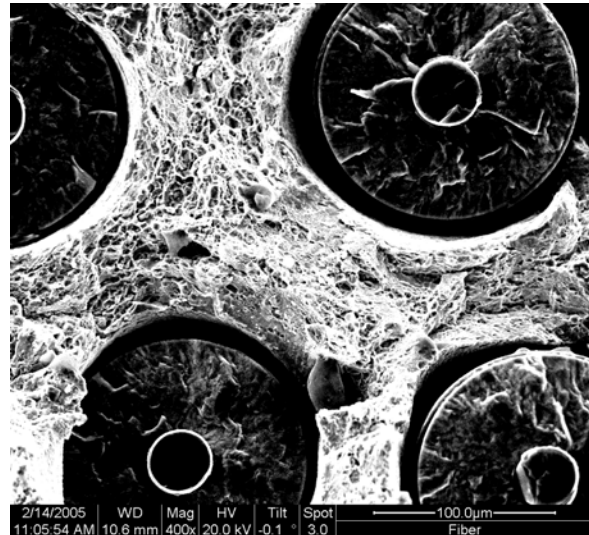
Figure 78: Specimen TMC-06, ductile void coalescence and necking

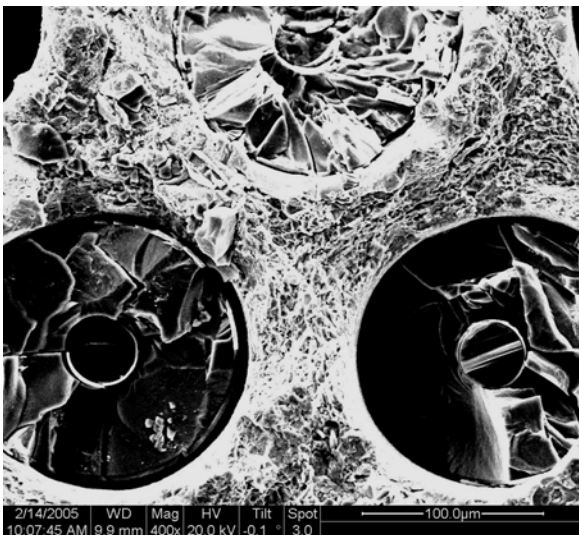
Figure 80: Specimen TMC-04, 1: catastrophic fiber failure

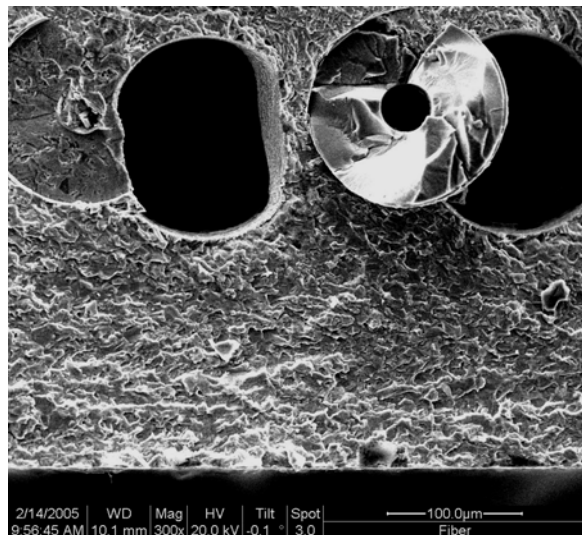
Figure 81: Specimen TMC-04, 2: fiber failure and compression damage

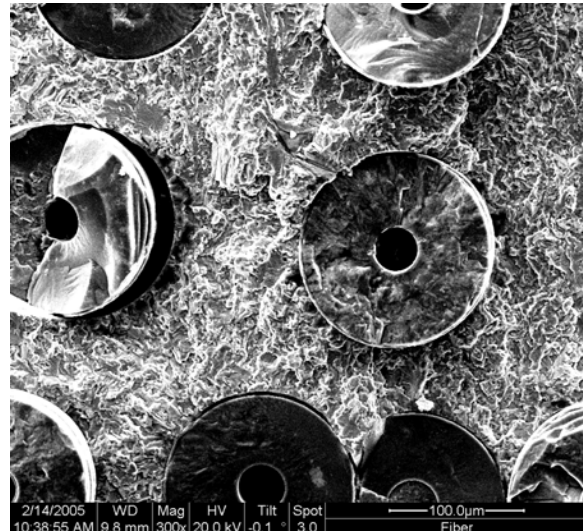
Figure 83: Specimen TMC-05, mixed mode failure

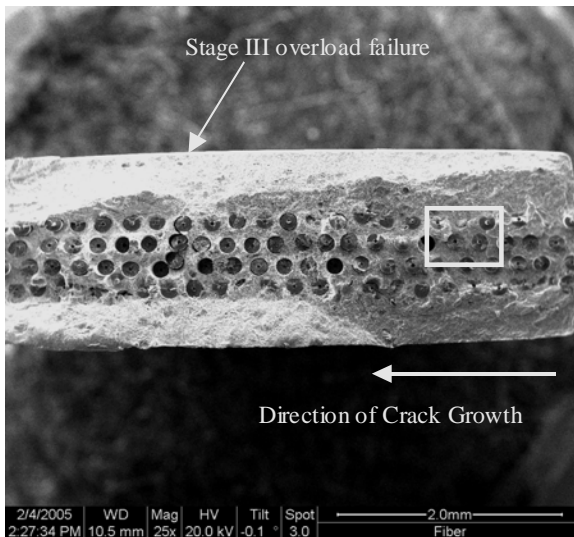
Figure 86: Specimen F/G-09, fracture surface (looking toward composite side)

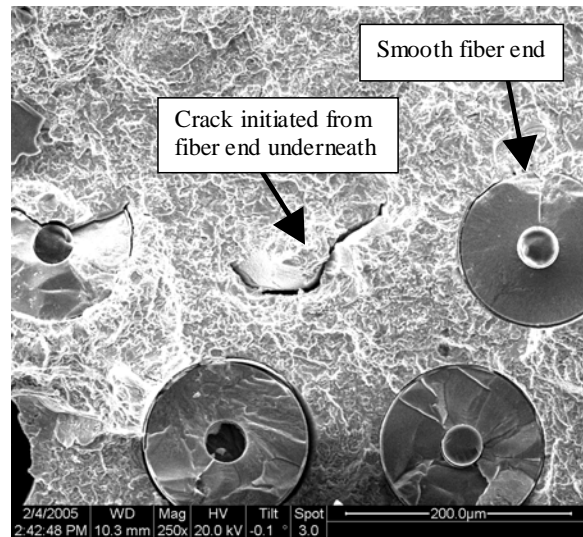
Figure 87: Specimen F/G-09, close-up showing crack originating from fiber end

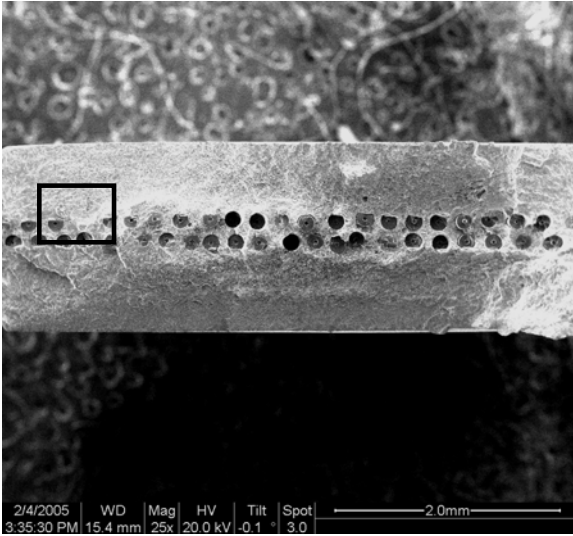
Figure 90: Specimen F/G-06, fracture surface (looking toward alloy side)

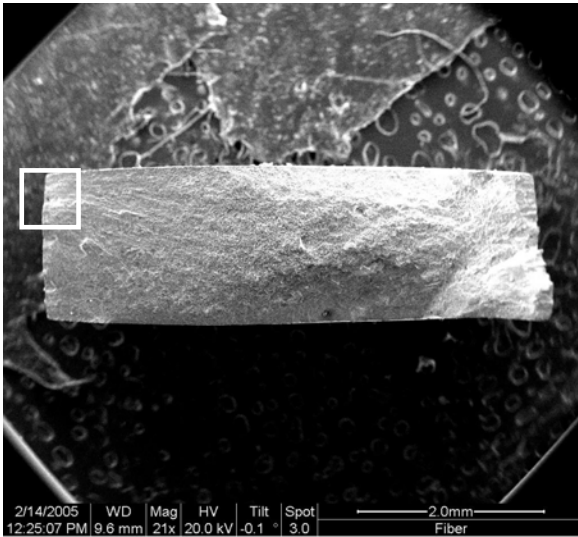
Figure 92: Specimen F/G-04, overall view of fracture surface

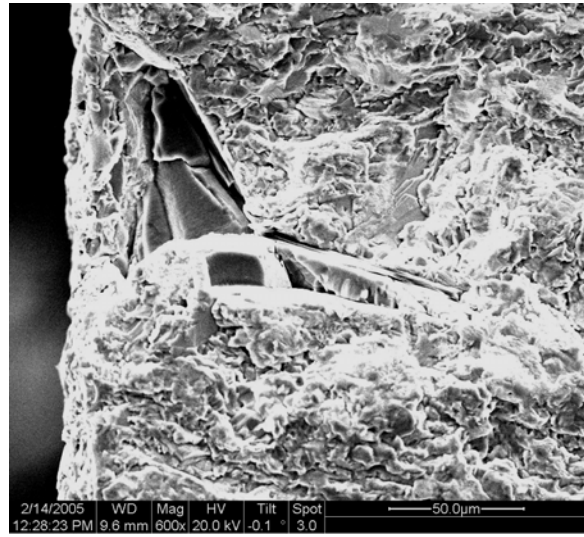
Figure 93: Specimen F/G-04, close-up showing matrix flow

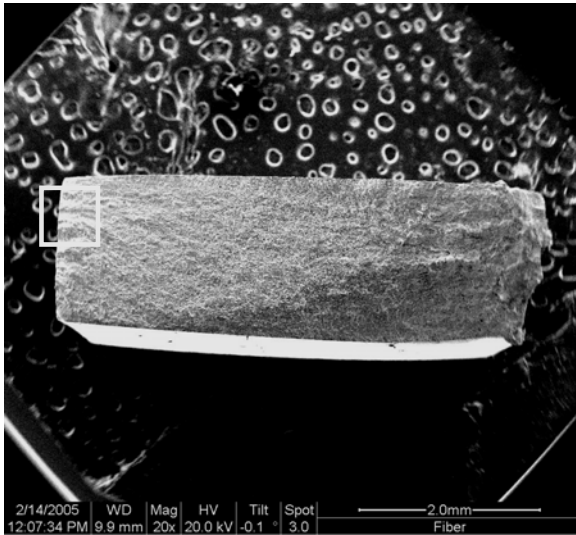
Figure 94: Specimen F/G-05, overall view of fracture surface

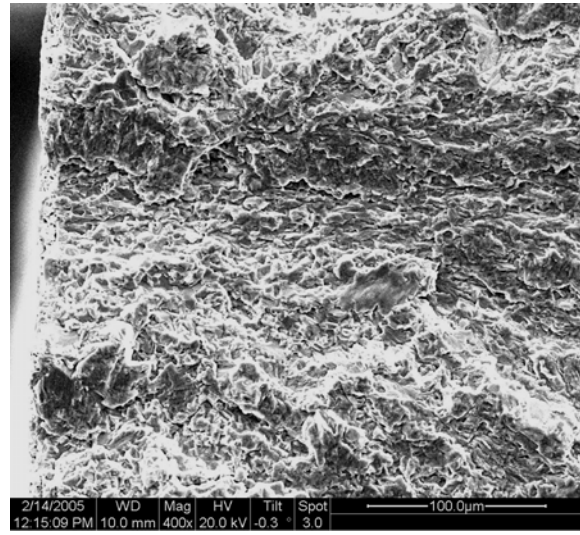
Figure 95: Specimen F/G-05, closeup of crack initiation site

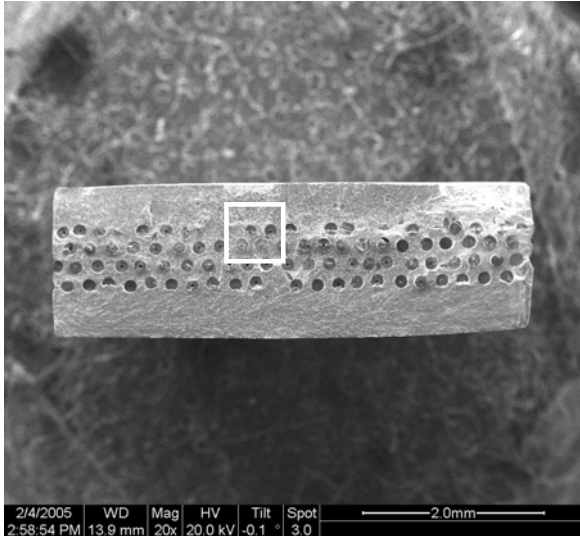
Figure 97: Specimen F/G-08, fracture surface (looking toward alloy side)

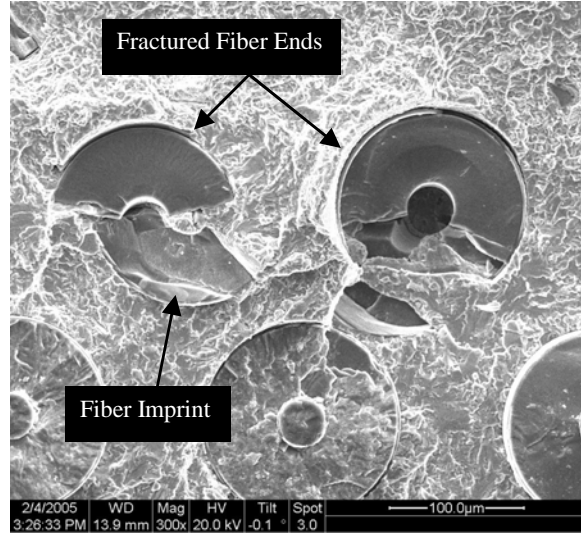
Figure 98). This figure, looking toward the pure alloy side of the specimen, shows a fiber imprint with a fractured piece of fiber on the left and more fractured pieces on the right.

Figure 98: Specimen F/G-08, fractured fiber ends

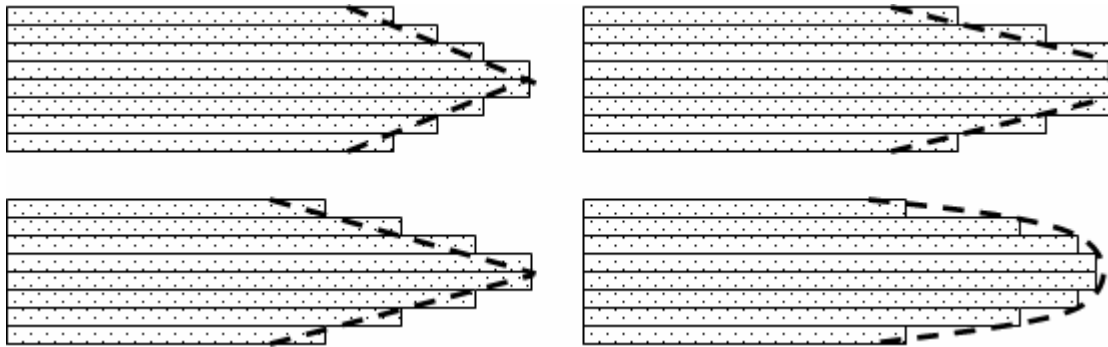
Figure 99: Sample ply lay-ups for taper region

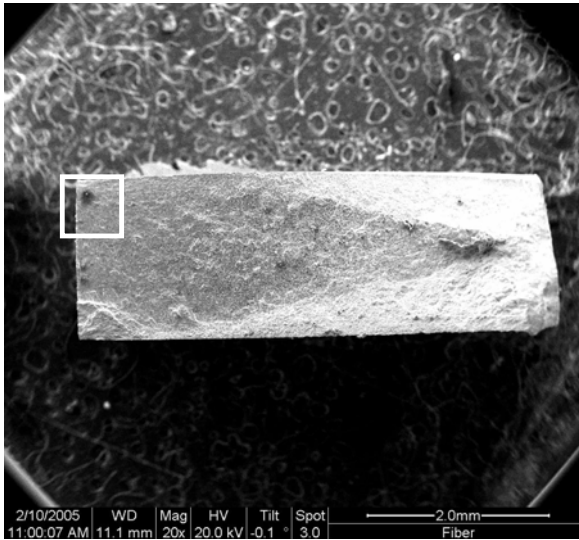
Figure 105: Specimen Ti-04, overall view of fracture surface

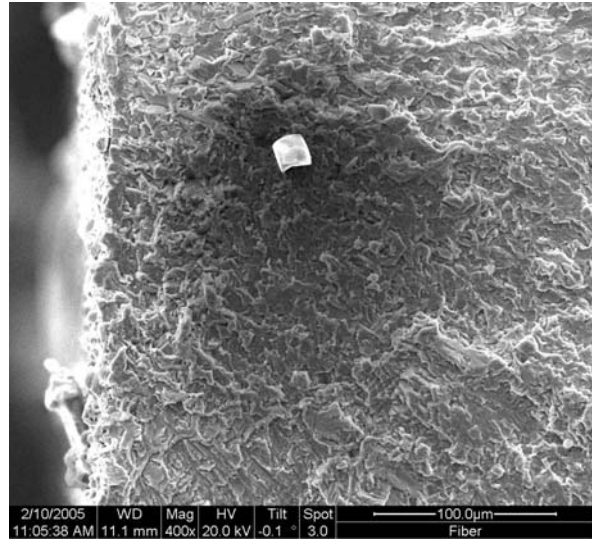
Figure 106: Specimen Ti-04, close-up view of void

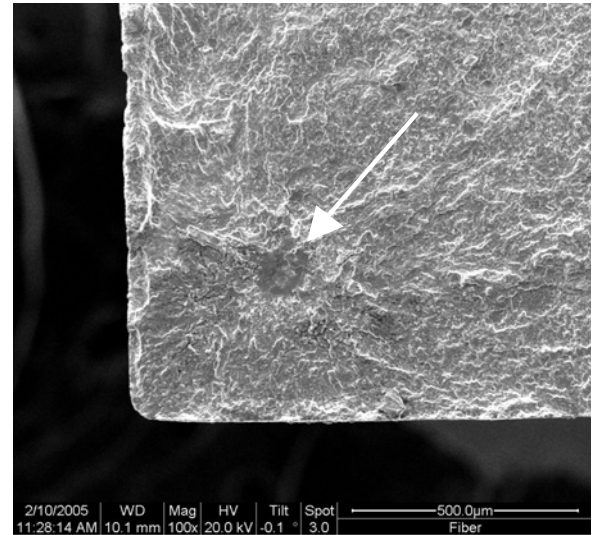
Figure 108: Specimen Ti-10, close-up of crack initiation site

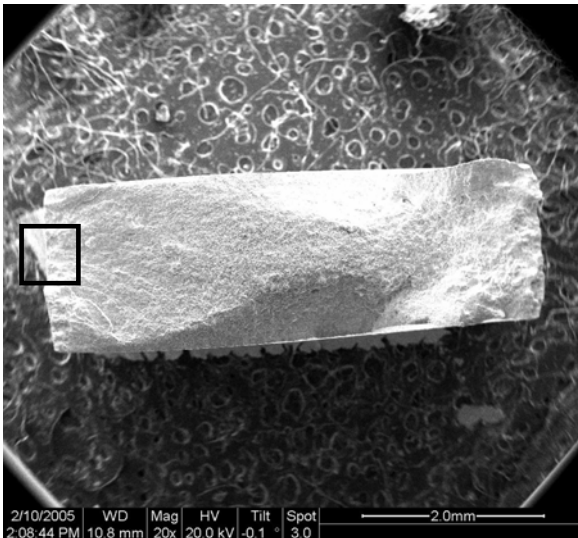
Figure 109: Specimen Ti-05, overall view of fracture surface

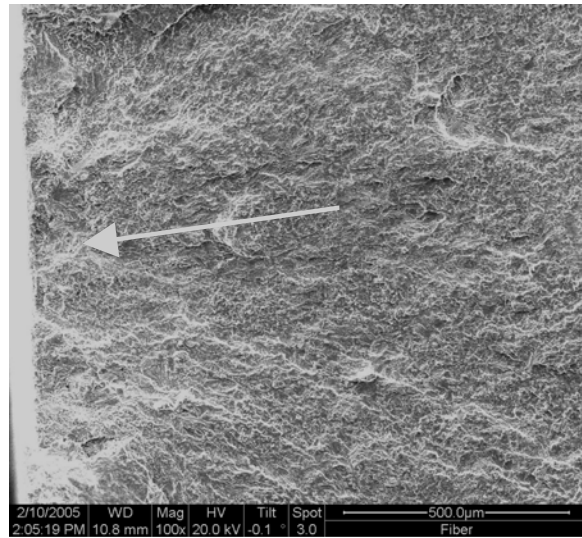
Figure 110: Specimen Ti-05, close-up view of crack initiation site

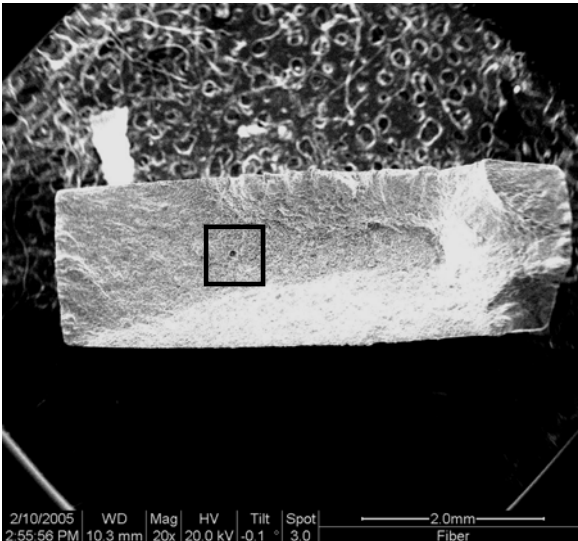
Figure 111: Specimen Ti-07, overall view of fracture surface

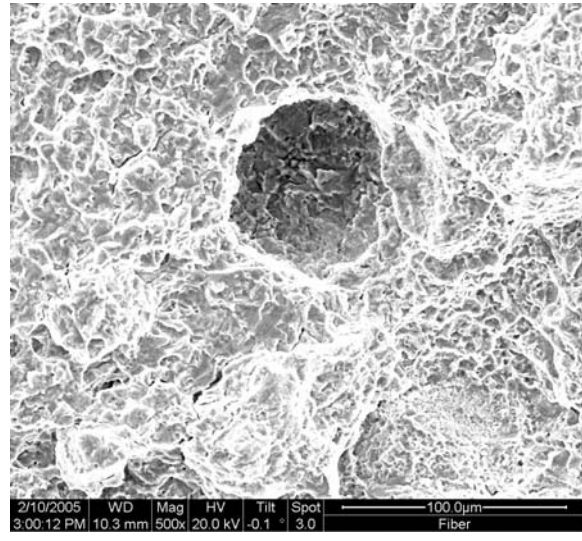
Figure 112: Specimen Ti-07, close-up of void in crack path

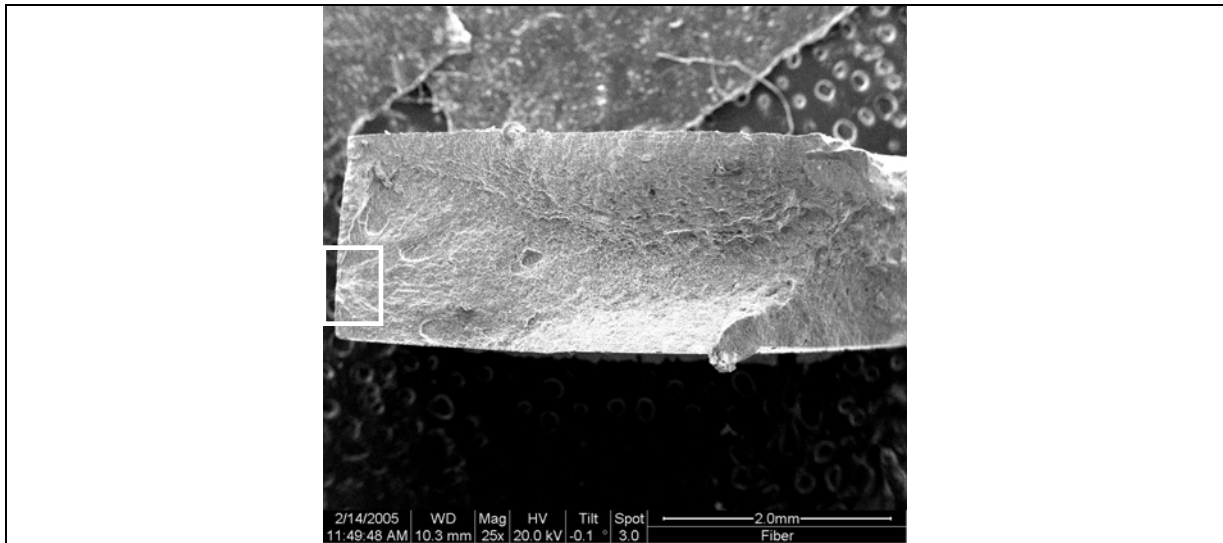
Figure 113: Specimen Ti-09, overall view of fracture surface

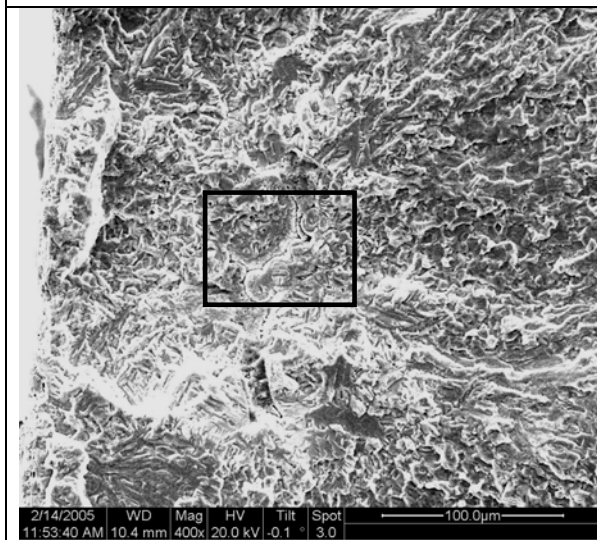
Figure 114: Specimen Ti-09, close-up of crack initiation site

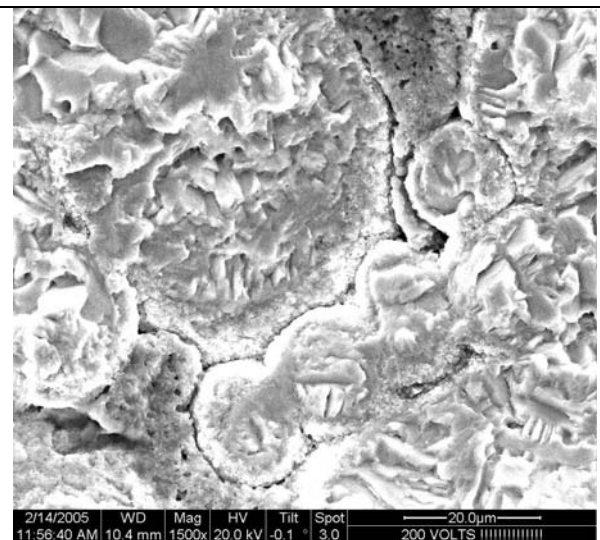
Figure 115: Specimen Ti-09, slip plane
